Old Mill Road Bridge Replacement

Review of Environmental Factors

Prepared By: Carley McGregor
Date: December 2023

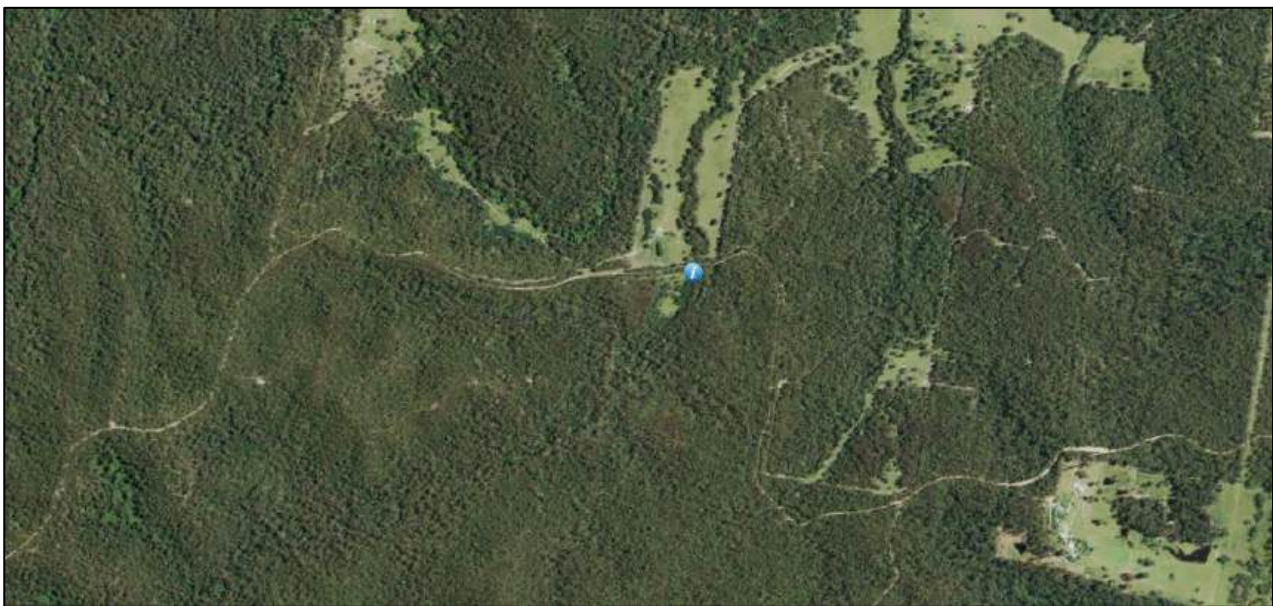
Image 4. Subject Site

The site is located in a dense state forest, with an open paddock to the north. The existing bridge is a single lane timber bridge with unsealed road pavement either side of the bridge. The length and width of the bridge are approximately 6m and 3m, respectively.

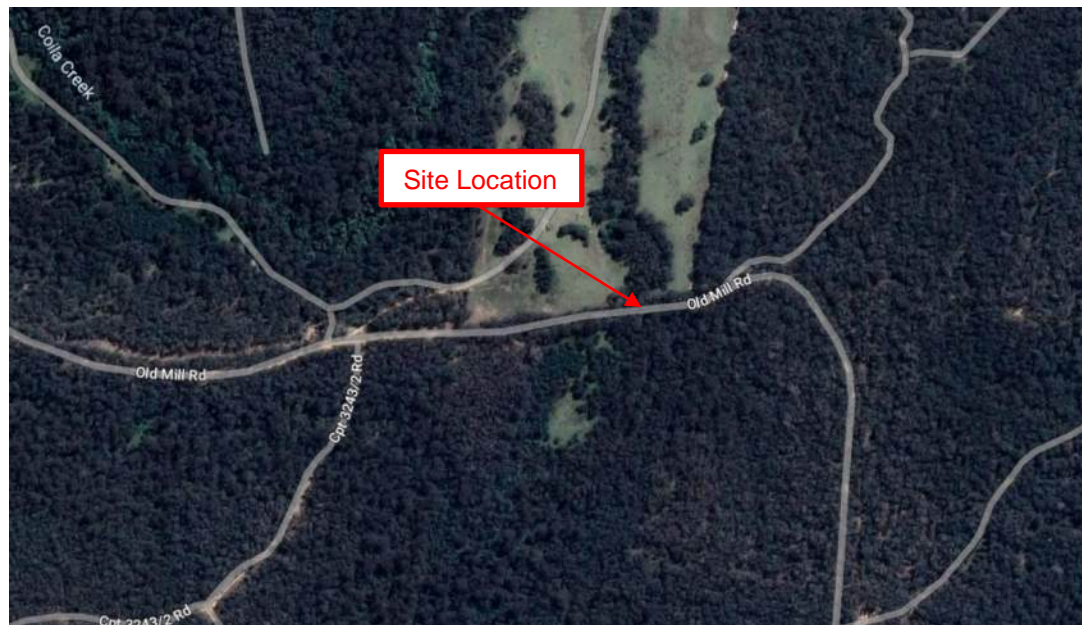
Figure 2-1 Site Location

Onsite observations show that the site is located in a dense state forest, with an open paddock to the North. The existing bridge is a single lane timber bridge with unsealed road pavement either side of the bridge. The length and width of the bridge are approximately 6m and 3m, respectively.

The site of the existing and proposed bridge is located at chainage 4.0 km along the Old Mill Road from the intersection of Old Mill Road and Prince Highway (A1). The site featured a single-span single-lane timber bridge crossing over a small creek. The site location is shown Figure 2-1 with imagery from Google Earth below.

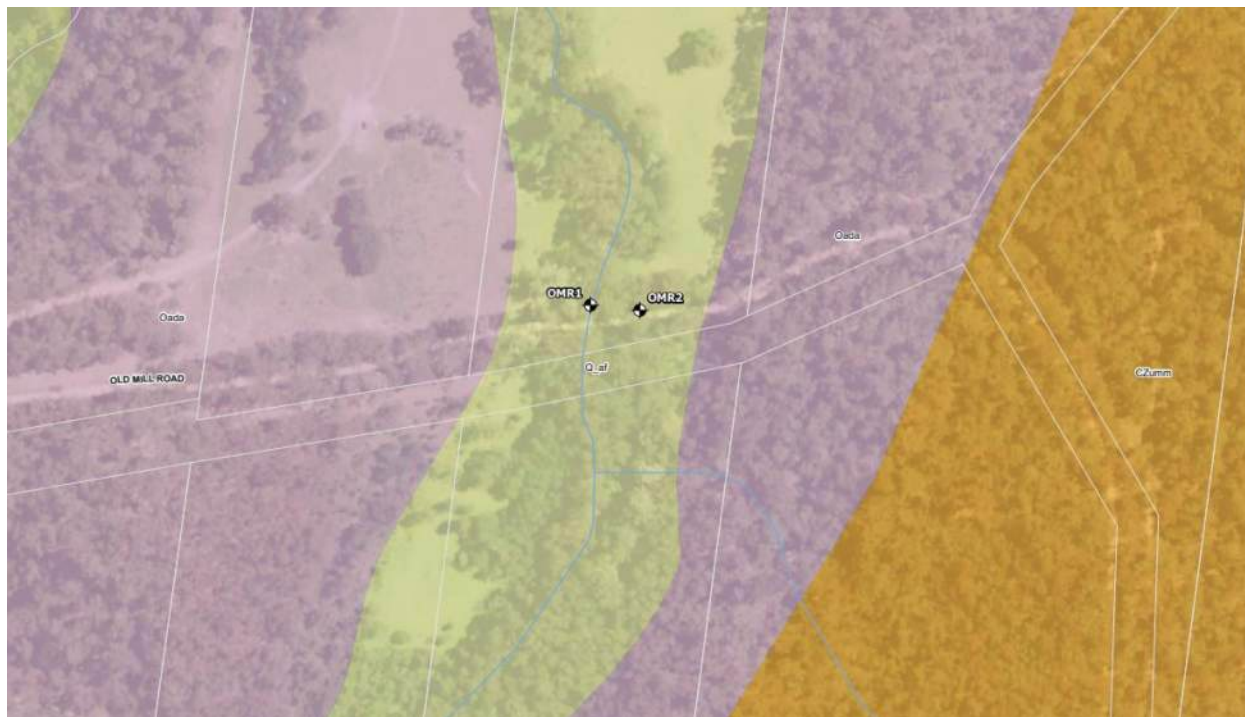
Figure 2-2 Regional Geology

The regional geology is presented in Figure 2-2 below with a full copy provided in Attachment A.

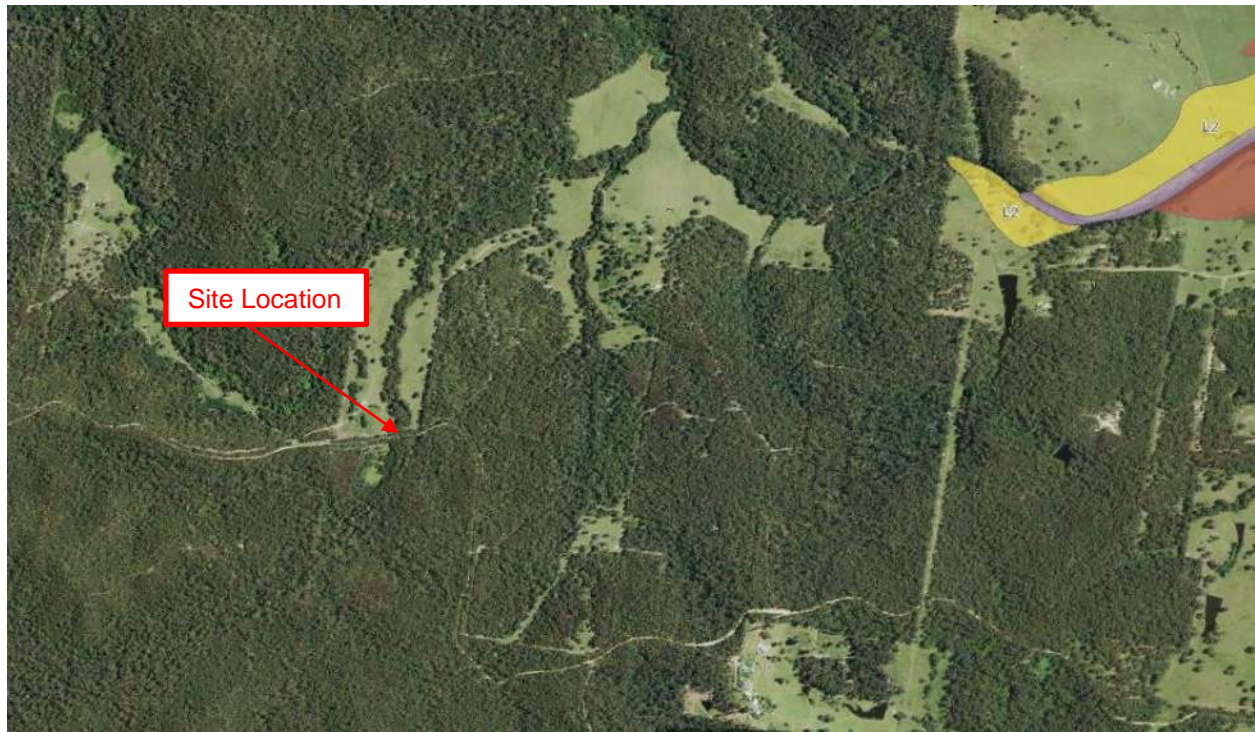
Figure 2-3 Acid Sulfate Soil Risk Mapping

Acid Sulfate Soil forms within waterlogged soils deposited under estuarine conditions. A review of the eSpade soil mapping website (NSW Department of Planning, Industry and Environment, 2023) Acid Sulfate Soils Risk mapping, indicates there is 'no data for the site'. To the north of the site 'no known occurrence' is recorded at a similar elevation. This is shown on Figure 2-3 below.

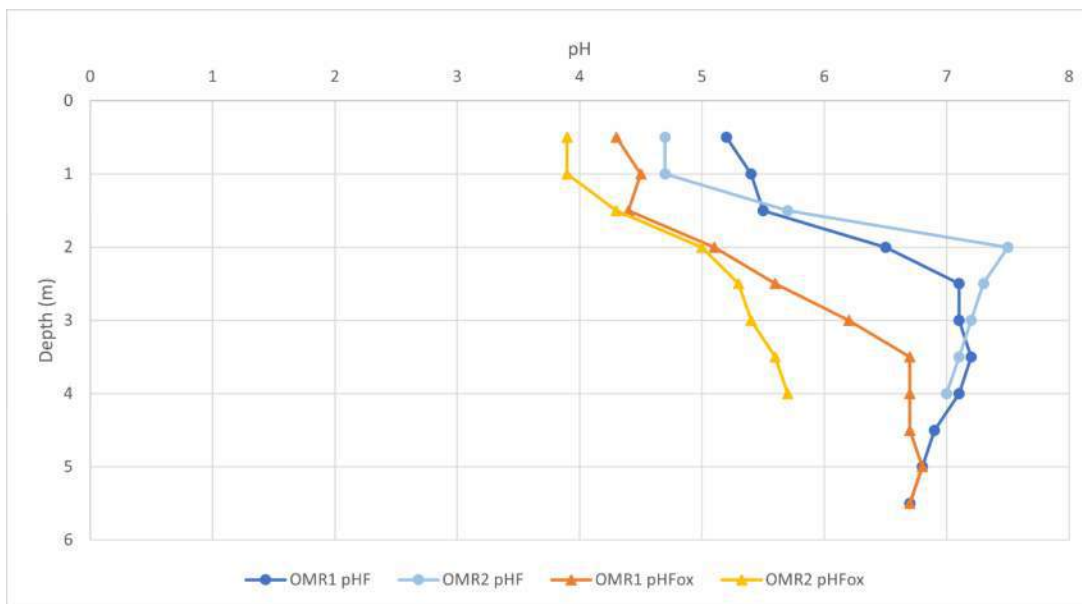
Figure 3-1: pH vs Depth (m) in OMR1 and OMR2

Based on the above results, sample OMR2 1.0 was submitted for chromium reducible sulfur suite analysis to determine whether the results indicate potential acid sulfate soils. The sample was selected as it had the lowest pHFox after the field screen. Results are presented in Table 3-8 and indicate that the analysed samples are potential ASS.

Samples were tested and screened for acid sulfate soils (ASS) and results show soils in-situ are slightly acidic to neutral with decreasing acidity with depth and following oxidation change in pH is between 0 and 2.5 and appears to decrease with depth. Full analysis is found in the geotechnical investigation (Appendix C). Conclusions indicate that the analysed samples are potential ASS.

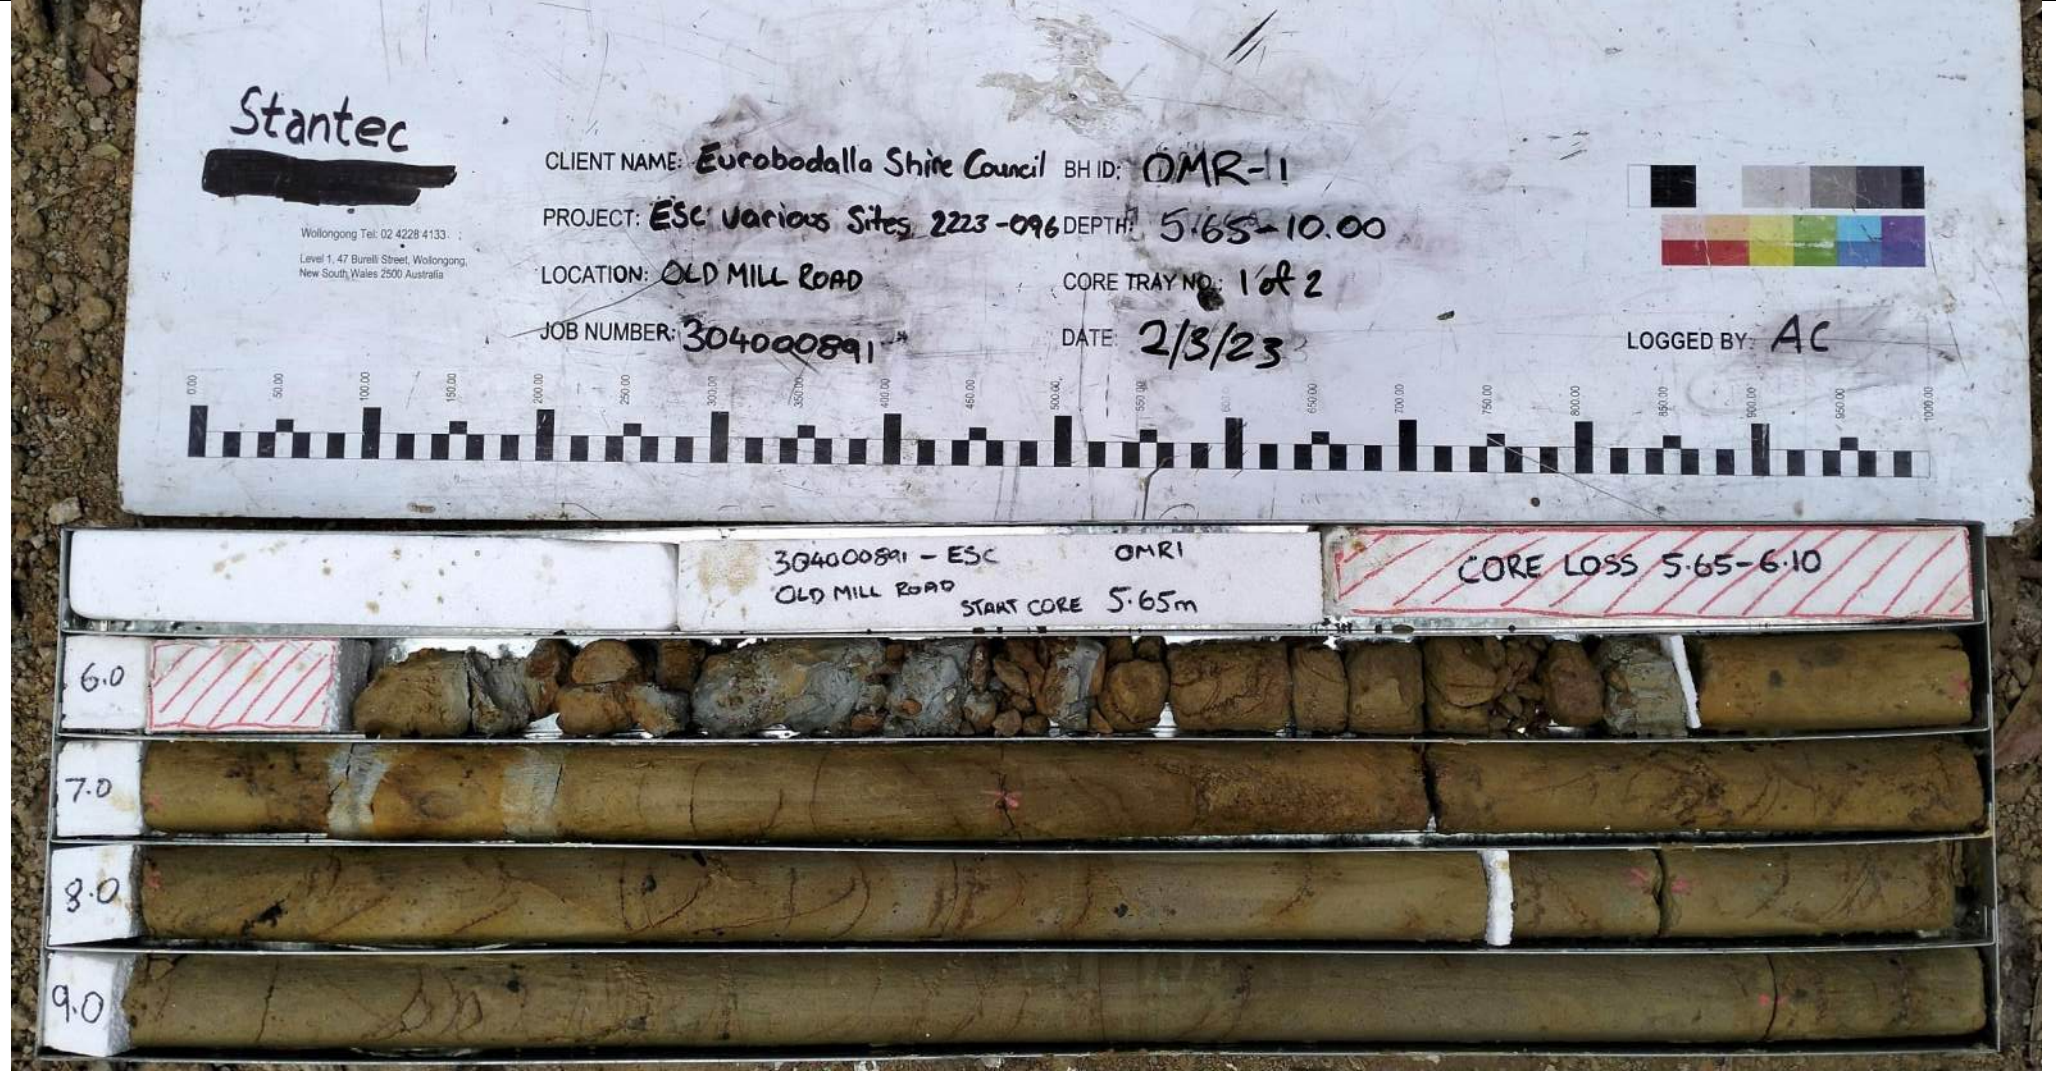
TITLE		BOREHOLE CORE PHOTOGRAPH-OMR1 ESC – VARIOUS SITES	
PROJECT NUMBER 304000891	TEST DATE 2/3/2023	INCLINATION -90 DEGREES	CORE LENGTH: BOX 2 of 2 10.0 m to 13.1 m – 3.1
DRILL RIG: HANJIN D&B 8D	CONTRACTOR: Total drilling	LOGGED BY: AC	CHECKED BY: TC

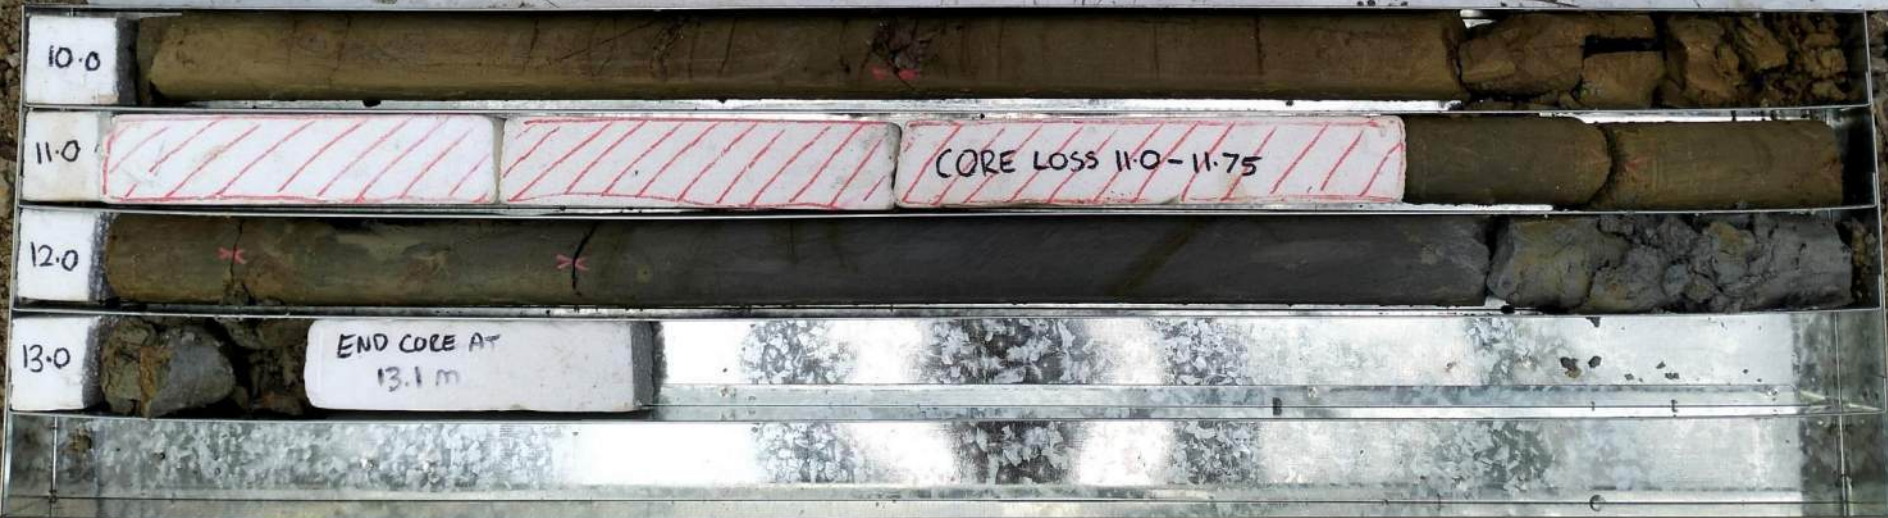
Client: Eurobodalla Shire Council Project: ESC Various Sites Location: Old Mill Road	Job No: 304000891 Position: E235570.970 N6010109.522 56 MGA20 Rig Type: Hanjin D&B 8D Casing Diameter:	Sheet: 1 of 4 Angle from Horizontal: 90° Surface Elevation: Mounting: Track Driller: JM Contractor: Total Drilling Checked By: RDJ
Data Started: 2/3/23 Date Completed: 2/3/23 Logged By: AC

Drilling			Sampling & Testing		Material Description							
Method	Resistance	Casing	Water	Sample or Field Test	Depth (m)	Graphic Log	Classification	SOIL TYPE, plasticity or particle characteristic, colour, secondary and minor components ROCK TYPE, grain size and type, colour, fabric & texture, strength, weathering, defects and structure	Moisture Condition	Consistency Relative Density	STRUCTURE & Other Observations	
AD/T			Not Observed	ES 0.50 m	0.5		CI	CLAY: medium plasticity, mottled brown, grey	M (>PL)	F to St	RESIDUAL SOIL	
				ES 1.00 m SPT 1.00 - 1.45 m 2, 4, 3 N=7	1.0			CL	Sandy CLAY: low plasticity, mottled brown, grey, fine to coarse grained sand	M (>PL)		F to St
				ES 1.50 m	1.5							
				ES 2.00 m	2.0		CL	Clayey SAND: fine to coarse grained, sub-rounded to sub-angular, grey, orange, medium plasticity clay, with fine to coarse quartz gravel	M	D		
				ES 2.50 m SPT 2.50 - 2.95 m 4, 6, 6 N=12	2.5		CL

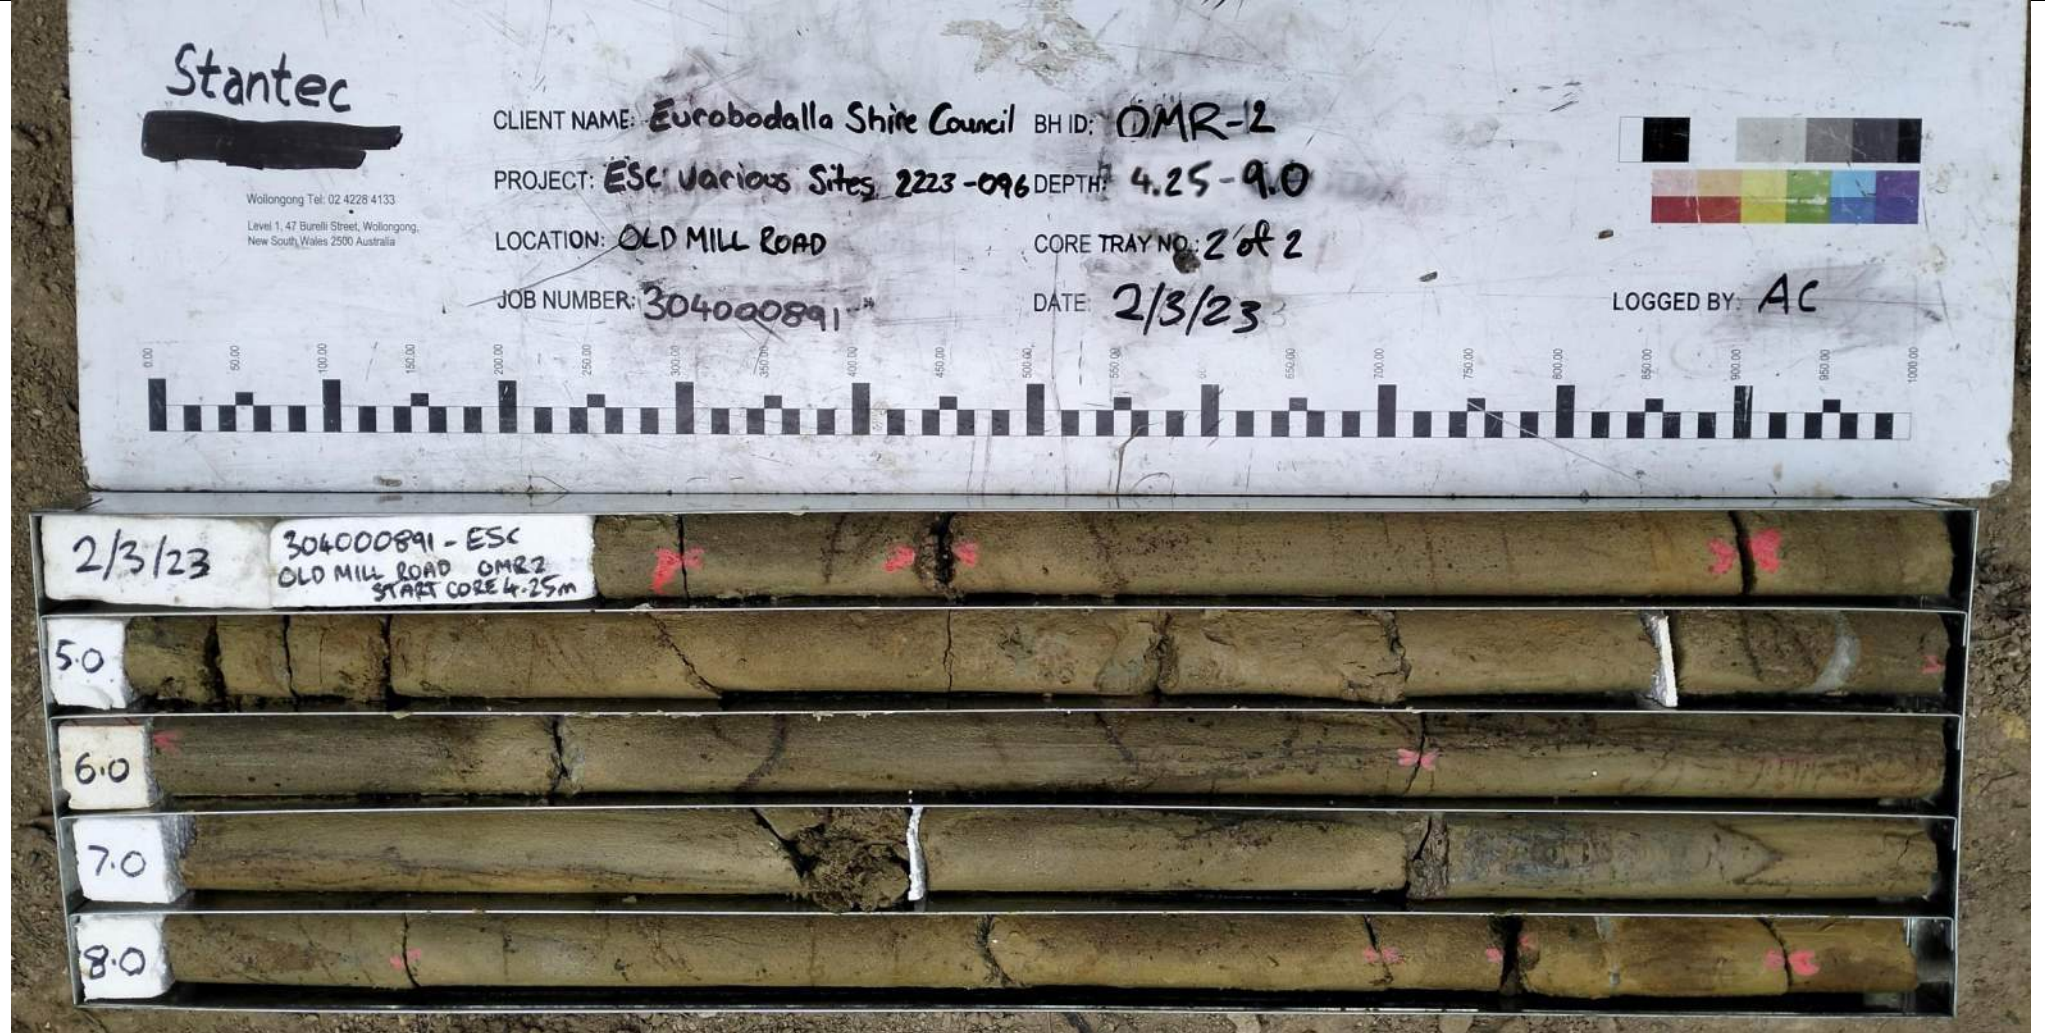
TITLE		BOREHOLE CORE PHOTOGRAPH-OMR2 ESC – VARIOUS SITES	
PROJECT NUMBER 304000891	TEST DATE 2/3/2023	INCLINATION -90 DEGREES	CORE LENGTH: BOX 2 of 2 9.0 m to 9.25 m – 0.25 m
DRILL RIG: HANJIN D&B 8D	CONTRACTOR: TOTAL DRILLING	LOGGED BY: AC	CHECKED BY: TC

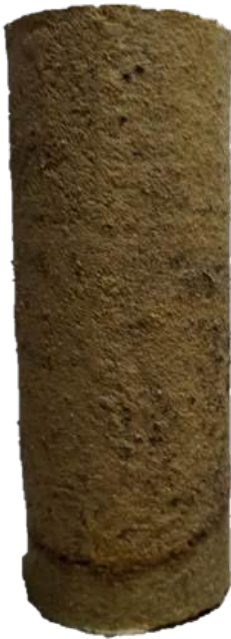
Specimen - Before Testing

Depth	7.30-7.60m		
Lithological Description	Sedimentary		
Type of Testing Machine	ROCK UCS PH1		
Date of Test	21/03/2023		
Height (mm)	146.0		
Diameter (mm)	50.9		
Test Duration (mins)	3.20	Rate Displacement (mm/min)	0.05
UCS (Mpa)	1.2	Moisture Content (%)	8.7

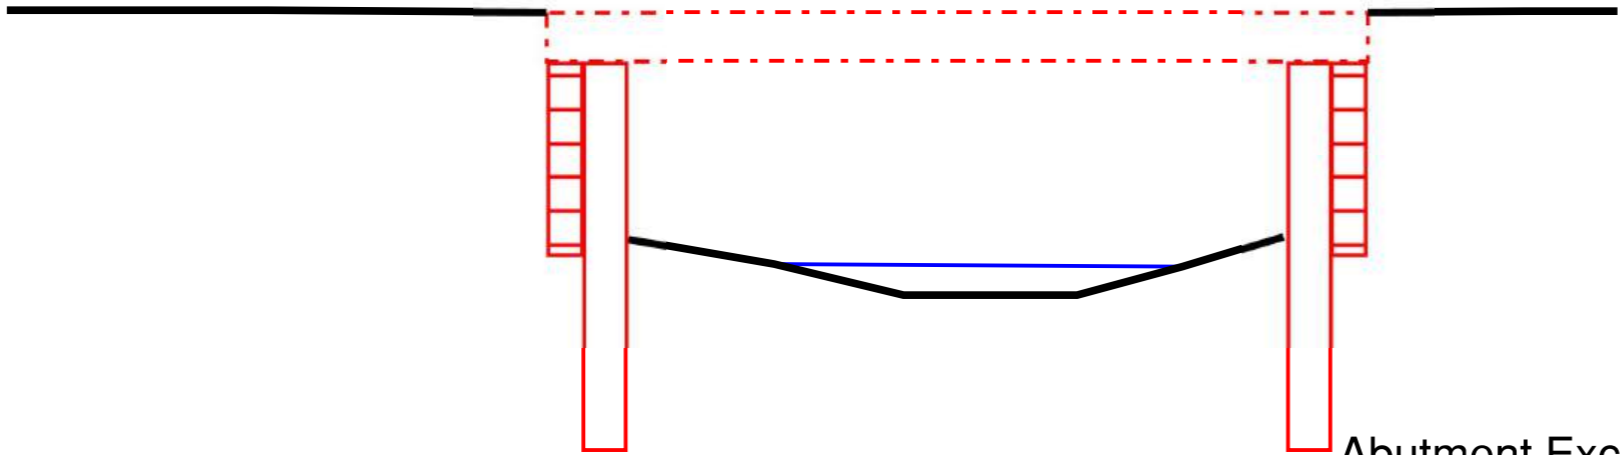
Abutment Excavation Plan View

- Remove transverse decking from the bridge deck
- Lift out the existing bridge bearers using an excavator or crane /pending weight of beam.
- The existing bridge abutments will be removed simultaneously as abutment excavation is carried out.

- Both abutments will be excavated down to underside of the new abutment.
- All fill can be stockpiled on site for later reuse
- This excavated platform will then be used to facilitate pile installation

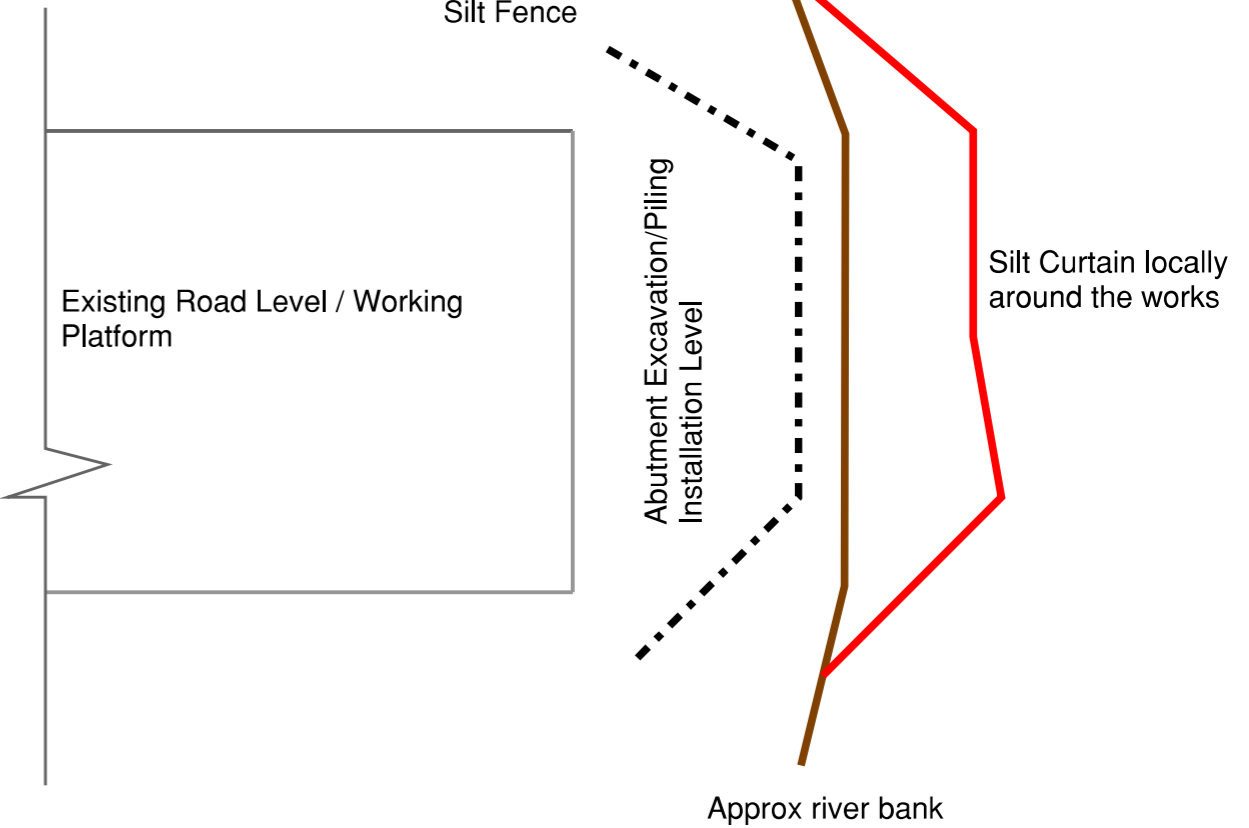
Step 01 Pitch the pile and secure/stabilise with the excavator and grabs

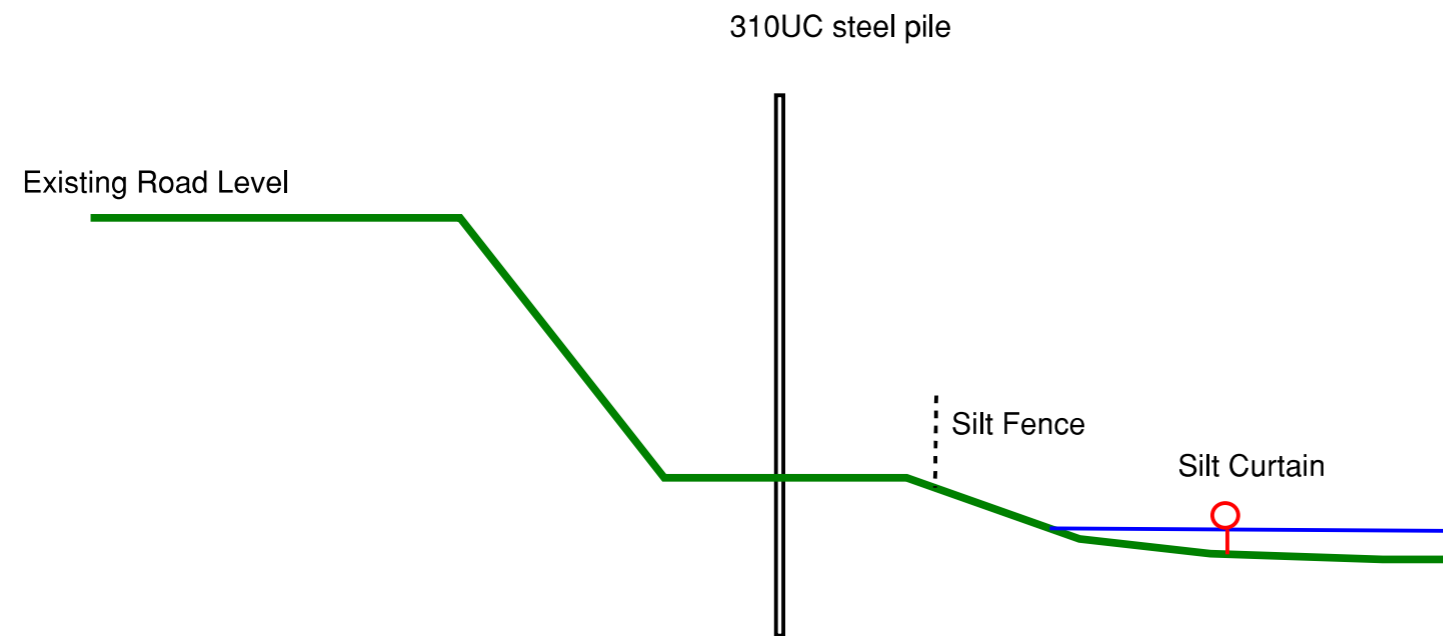
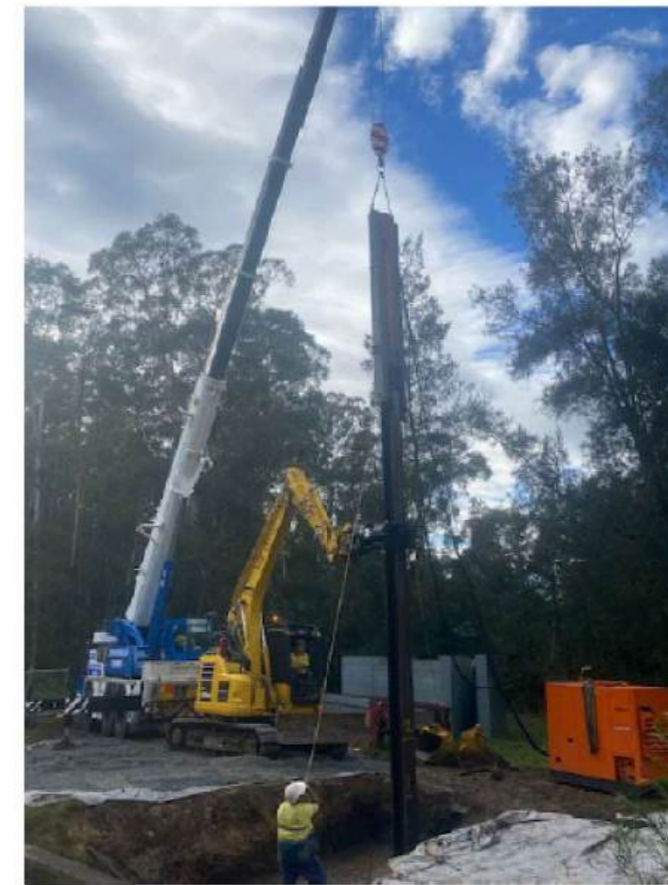
Step 02 - Drive to refusal with Dawson Hammer

- Lift the Dawson Hammer into position with a mobile crane
- Excavator and grabs maintains position of pile whilst the Hammer drives the pile
- Continue driving the pile using the Dawson Hammer, the pile get to point approx 4-5m embedment where the excavator will then release the pile as it will be no longer required and hammer will continue driving
- Drive to refusal and record sets

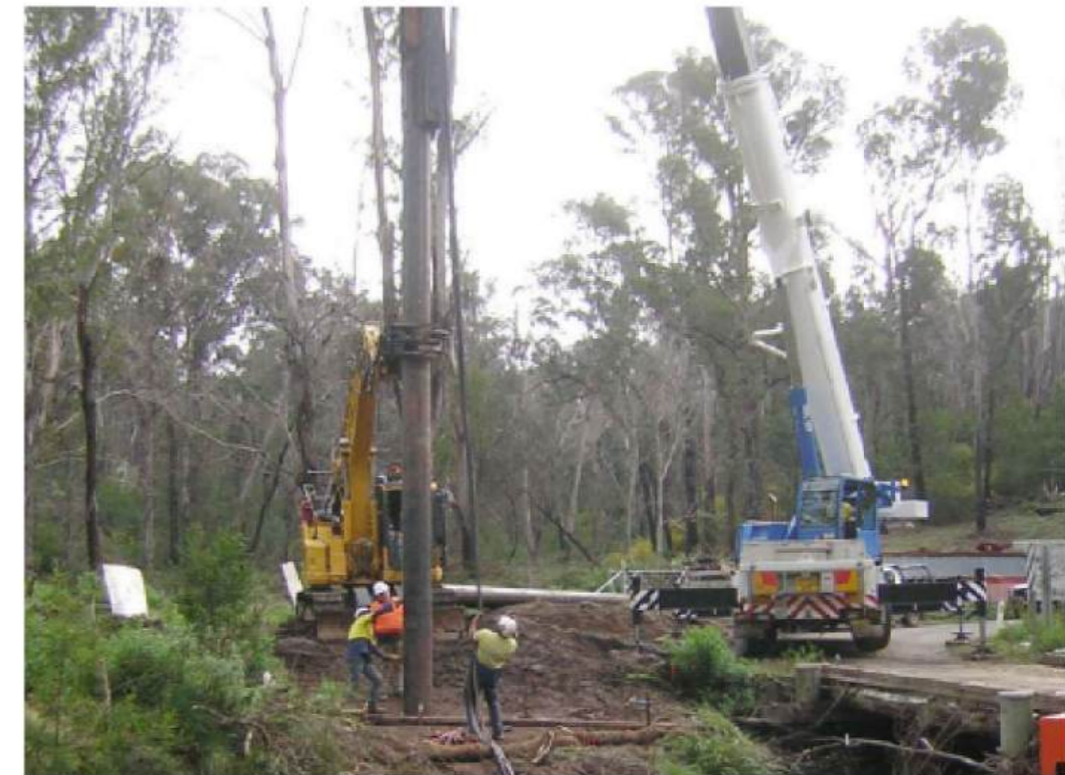
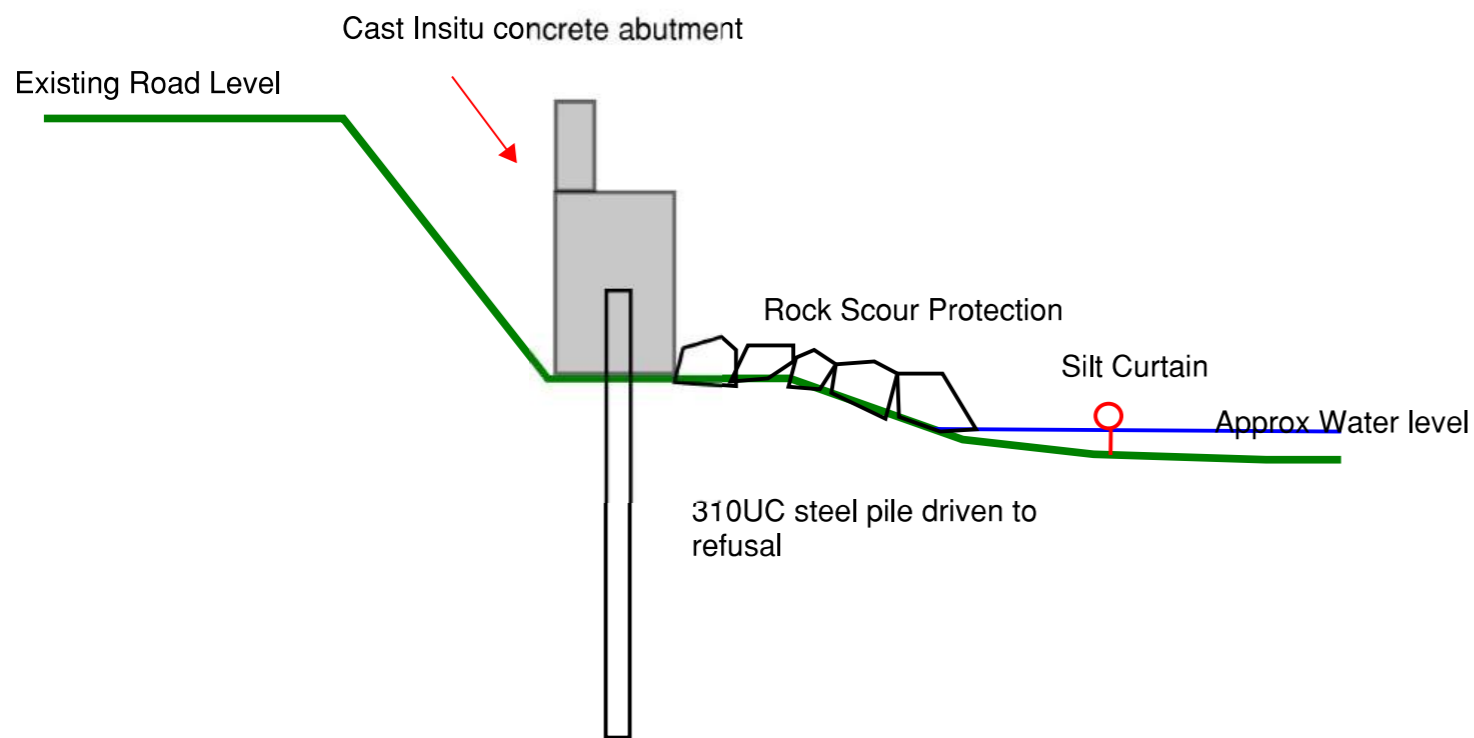
Abutment Installation

- Lift prefabricated reinforcement cages into position. Form up abutments and wing walls and pour concrete
- Localised rock scour protection will be placed at the front of the abutment.
- Abutments can be backfilled with existing material and compacted to standard.
- Lift the Precast concrete beams into position using an appropriately sized crane. Units will weigh approx 6.4tn each

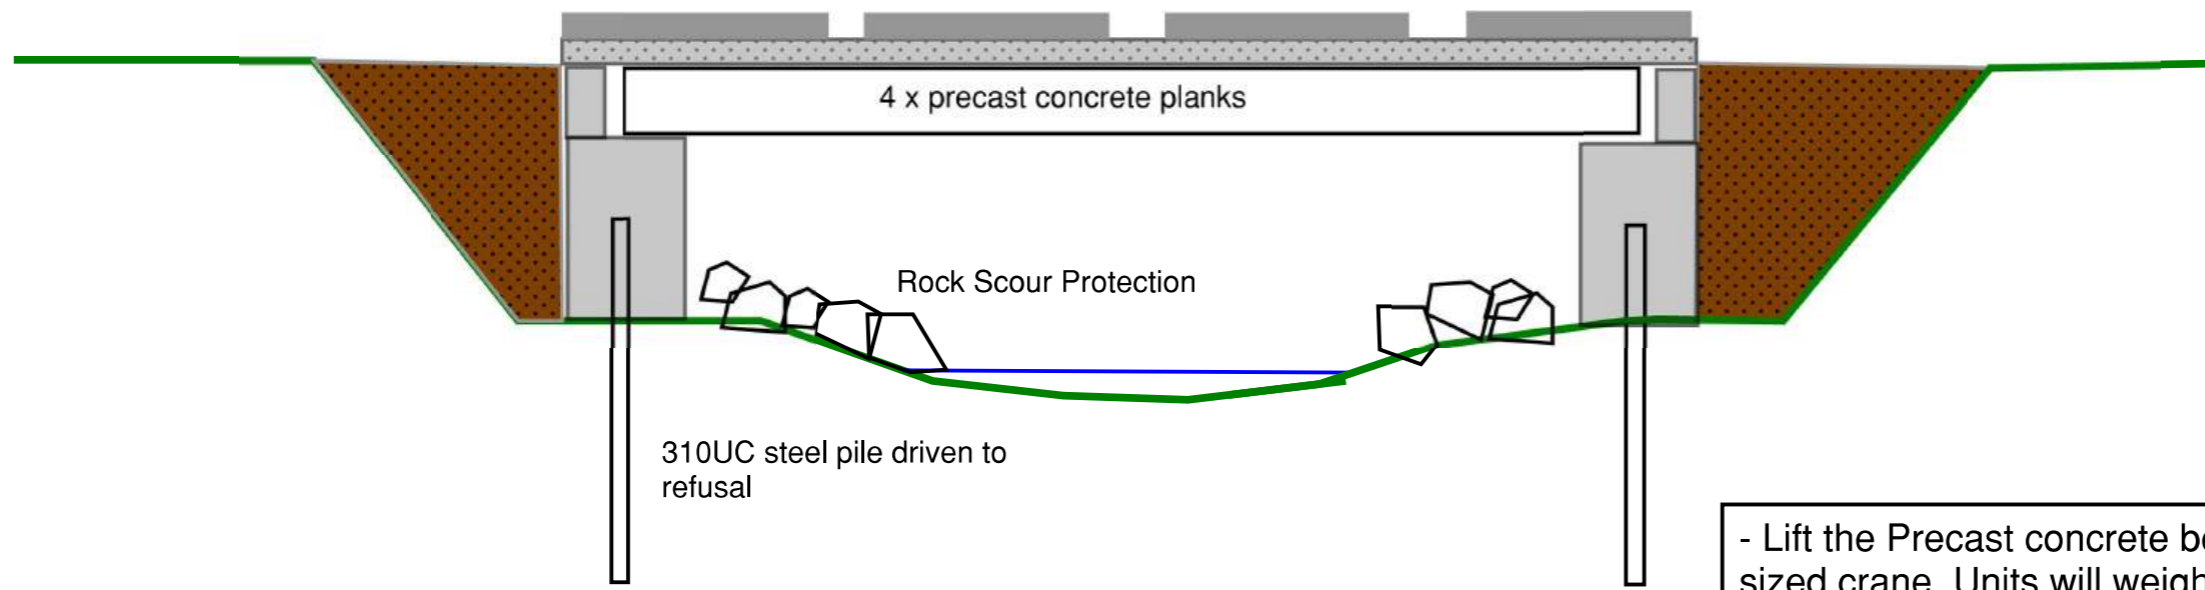
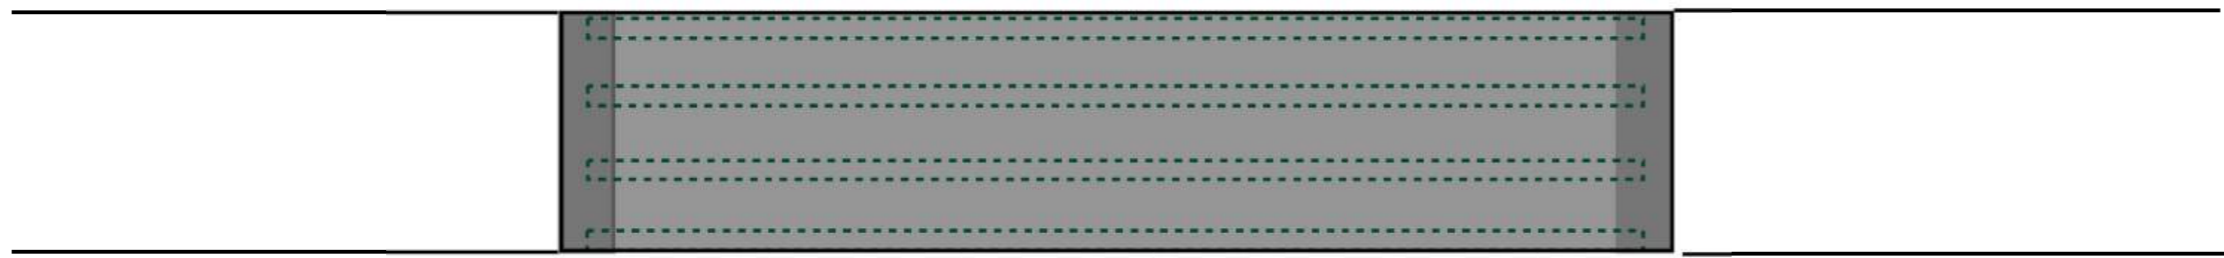
Deck Construction

- Lift the Precast concrete beams into position using an appropriately sized crane. Units will weigh approx 6.4tn each
- Install sacrificial formwork between each plank to support the wet concrete in the deck until concrete has gained sufficient strength
- Place reinforcement to deck and fix edge boards into position
- Pour concrete deck

Bondek or fiber-cement sheeting will be placed between the spaced beams as sacrificial formwork for the deck pour. All joints will be tested with water to ensure there are no leaks and to avoid the risk of any concrete slurry entering the water during the pour.
